Regional Sediment Management (RSM) Principles in Flood Recovery: Incorporating RSM after the 2011 Missouri River Flood

by Paul M. Boyd

PURPOSE. This Coastal and Hydraulics Engineering Technical Note (CHETN) summarizes actions undertaken during 2011 and 2012 to incorporate US Army Corps of Engineers (USACE) Regional Sediment Management (RSM) principles into a wide variety of projects as part of flood recovery and reconstruction on the Missouri River. Significant damage was caused by the 2011 Missouri River flood, and mitigation of sediment impacts and repair of infrastructure were given a high priority in an effort to return the flood protection system to acceptable flood protection levels.

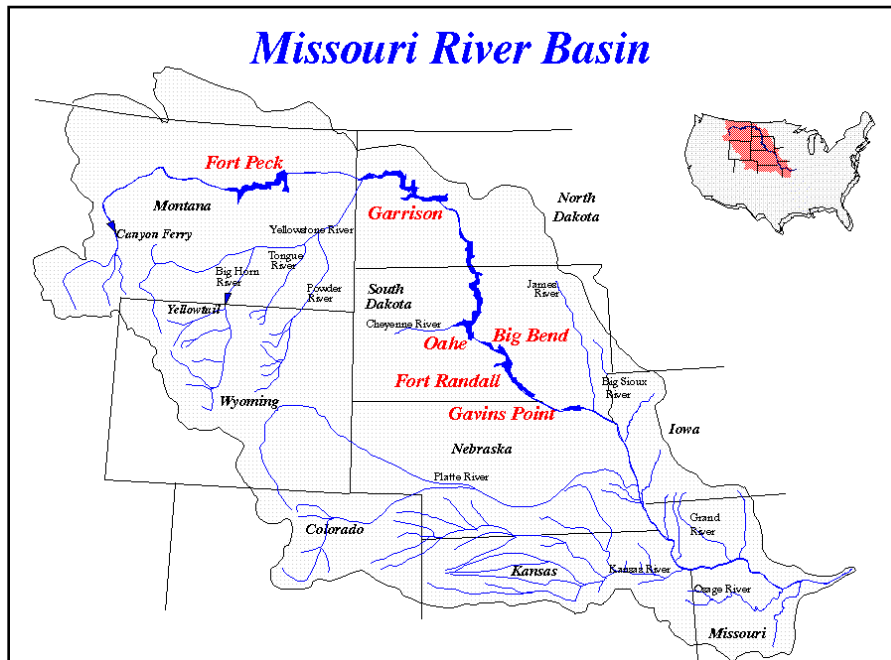
THE 2011 MISSOURI RIVER FLOOD. The Missouri River Mainstem System is made up of six large reservoirs with a total storage volume of nearly 75 million acre-feet (MAF). The dams were constructed between 1933 and 1965, and are operated as a system to meet eight congressionally authorized project purposes. Figure 1 shows the layout of the Missouri River Mainstem Reservoirs.

Figure 1. Missouri River mainstem reservoirs.

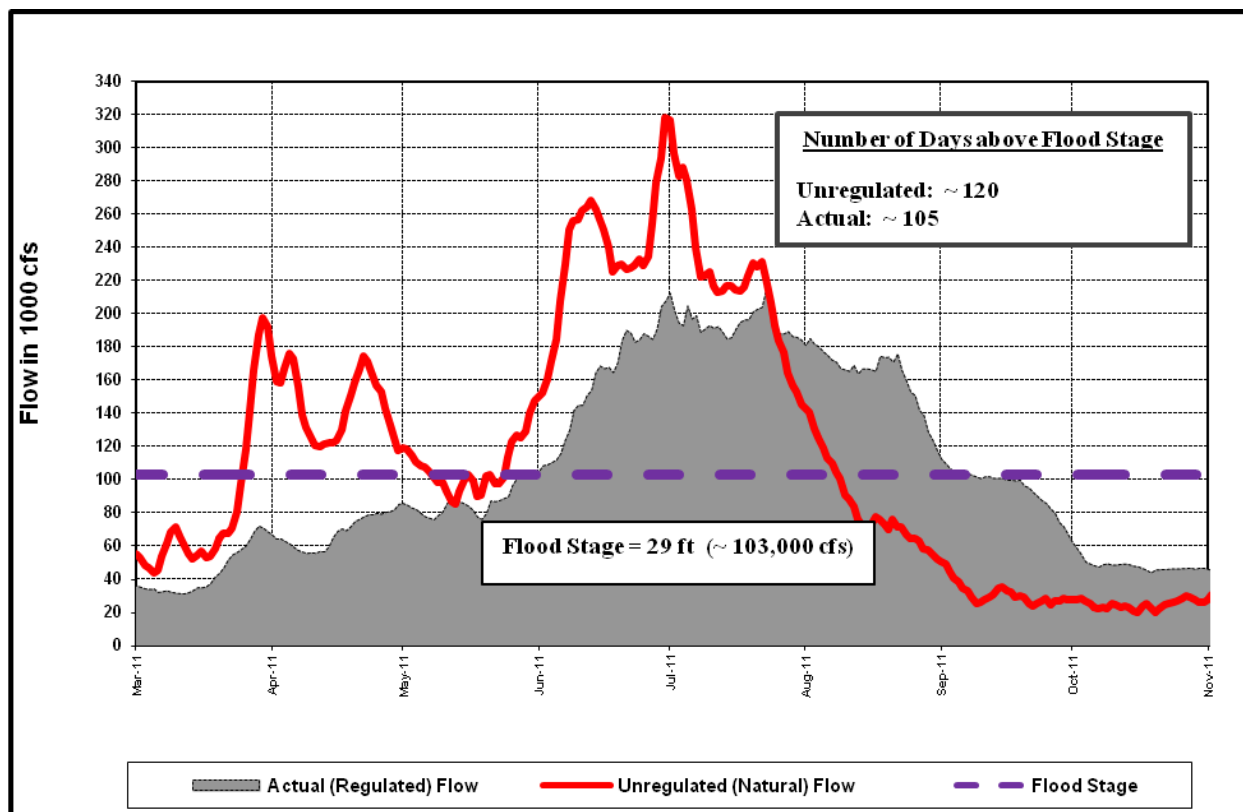
In an effort to quantify the effect of the reservoir system on the flood magnitude, the USACE Missouri River Basin Water Management Division projected the magnitude and duration of flows on the Missouri River during 2011 that would have resulted from an unregulated river (Figure 2). This figure shows the measured (actual regulated) and predicted (unregulated natural) hydrographs at Sioux City, IA (USACE 2012).

Figure 2. Measured (actual regulated flow) and predicted (unregulated natural flow) hydrographs of the Missouri River at Sioux City, IA.

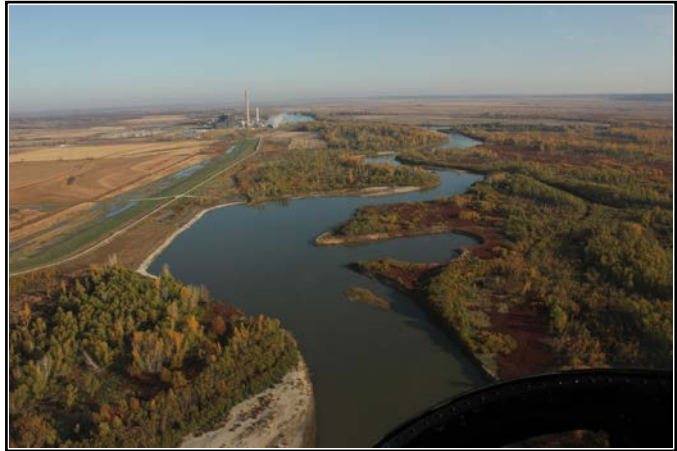
In the process of identifying a dredge material source, the design team consulted with engineers and biologists from the Missouri River Recovery Program (MRRP) tasked with designing and building appropriate habitat areas for the endangered Pallid Sturgeon. The MRRP worked with the design team to set the location, shape, and depth of an area that would meet the volume needs of the construction project, and that would create a backwater habitat area that qualifies as shallow water habitat. Completion of the project also included adding seepage blankets in multiple areas along the landward side of the levee. At the Upper Hamburg Chute site, less than 1% of the seepage blanket material was sourced from the dredging. However, at a second site just upstream, coarse sediments deposited in the river channel provided approximately 50% of the fill material needed. Figure 4 shows the final constructed repair, with the new levee toe on the left and the shallow water habitat backwater on the right.

Figure 4. Repaired Upper Hamburg Bend Chute, Missouri River.

- *Hamburg Bend Chute Shallow Water Habitat.* The use of local sediment for levee repair construction provided the opportunity to create a backwater habitat. The design team realized the need for additional levee repair material and went to the Missouri River Recovery Program for guidance on what would work best. One positive attribute of this effort was that RSM concepts did not need to be “forced into” the project; working through the RSM process was a natural extension of the project that inherently offered significant cost savings. In some of these projects, RSM principles offer obvious, common sense solutions; incorporating RSM is easily justified.

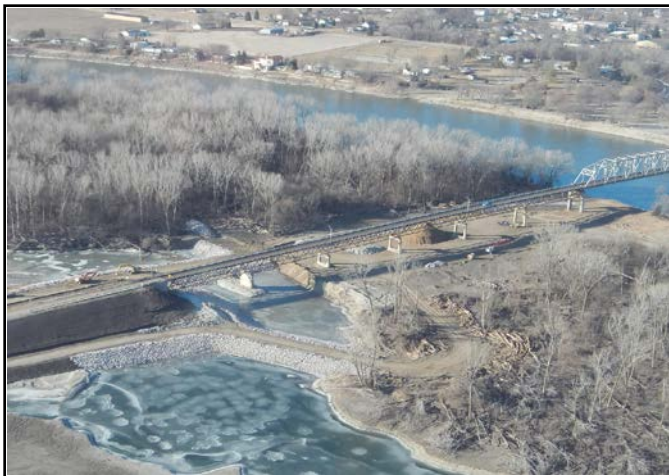
Decatur Bridge Repair. During the 2011 flood, the Highway 175 bridge crossing the Missouri River at Decatur, NE (RM 691), experienced significant erosion along the east end bridge abutment. As part of the effort to re-open the bridge, the abutment required significant fill and armoring for protection. During the flood, a channel formed along the nose of the abutment. This channel also caused damage to the State of Iowa Upper Decatur Bend Wildlife Management Area. As the State of Iowa developed plans to repair the bridge abutment, it became clear that additional protection was needed to prevent future damage. To build up and armor the bridge, a large amount of fill material was required. The river had formed an active channel at the toe of the abutment so very little material was available close by.

To address the need for large amounts of fill material, the Iowa Department of Transportation worked with USACE and the Iowa Department of Natural Resources (IDNR) to source material that also benefitted habitat creation. A number of shallow wetland areas were filled during the flood, and sandbar deposits in the Missouri River needed to be removed. Through a combination of excavation to deepen the wetlands and dredging to remove the sandbars, sufficient fill was sourced to build control structures and support bank stabilization on and around the bridge abutment. Figure 5 shows the completed project in the winter of 2011/2012. The entire project was completed in a matter of months to allow the highway to reopen.

Figure 5. Bridge abutment repair at Highway 175 bridge, Decatur, NE.

- *Decatur Bridge Repair.* This project was successful due to the highly qualified staff involved on both the State and Federal sides. Multiple meetings and site visits ensured that all parties were working with the same vision. As is often the case, working with professional staff having previous experience increases the possibility of adding other organizations that could support and/or benefit from the existing program plan.

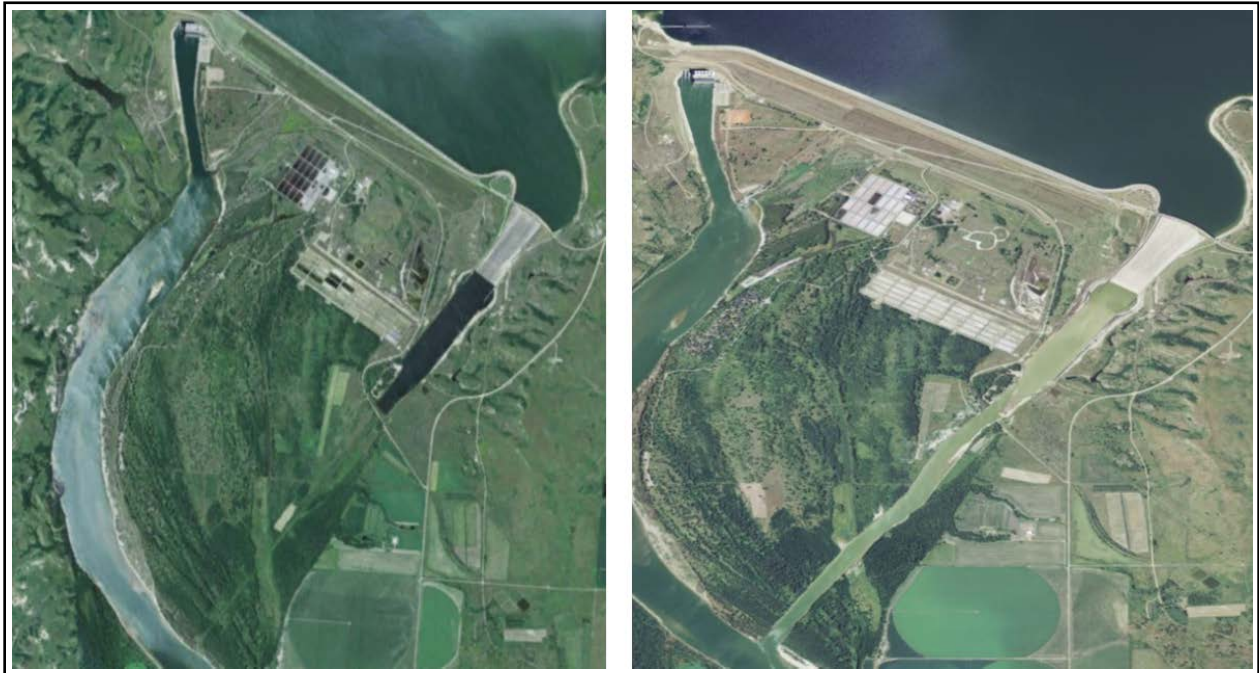
While the spillway was in use, the discharge passed through a pond at the foot of the spillway, and then through an earthen pilot channel that directed flow back to the Missouri River. Due to the magnitude and duration of the flood, the earthen channel experienced major erosion, resulting in a channel 300-ft wide and 10- to 15-ft deep. The flow also eroded the earthen embankment that served as the downstream shore of the spillway pond. The pond is part of a recreation area and serves as a water intake for the Garrison fish hatchery.

Figure 6 shows the spillway channel at Garrison Dam before and after the 2011 flood.

Figure 6. Garrison Dam spillway channel before (left) and after (right) the 2011 flood.

Surveys of the spillway channel indicated that approximately 900,000 cubic yards (cu yd) of material would need to be removed from the channel to regain full capacity. Approximately 100,000 cu yd of that material was attributed to 2011 flood deposits. Construction of settling ponds for the material would require hundreds of acres in an area with rolling hills and steep gullies. This solution was determined to be impractical. Two other proposed discharge locations were identified with sufficient volume: (1) disposal of the dredge material upstream of the dam on the lake bottom, and (2) filling the downstream spillway channel.
